# MOVE PROTECTS BRACKET

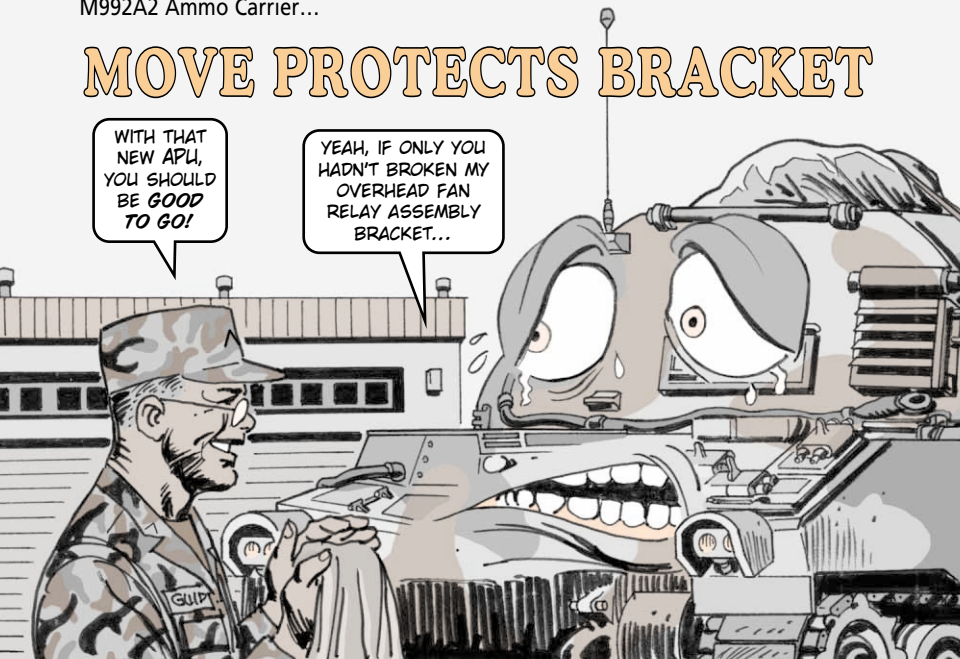
WITH THAT  
NEW APU,  
YOU SHOULD  
BE GOOD  
TO GO!

YEAH, IF ONLY YOU  
HADN'T BROKEN MY  
OVERHEAD FAN  
RELAY ASSEMBLY  
BRACKET...

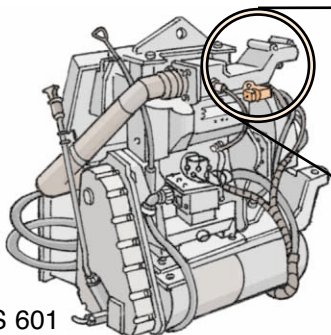
In its current position, the bracket is easily damaged when the APU is removed or installed. Since the bracket isn't available in the supply system, you have to replace the entire fan relay assembly, NSN 5945-01-456-6726.

Relocate  
fan relay  
assembly  
here

Protect the bracket by having your mechanic relocate the fan relay assembly to the backside of the APU intake shroud. The bracket attaches easily using one of the existing shroud mounting bolts.
